Recent Improvements

Traffic Volumes

Site Observations

Mitigation Alternatives

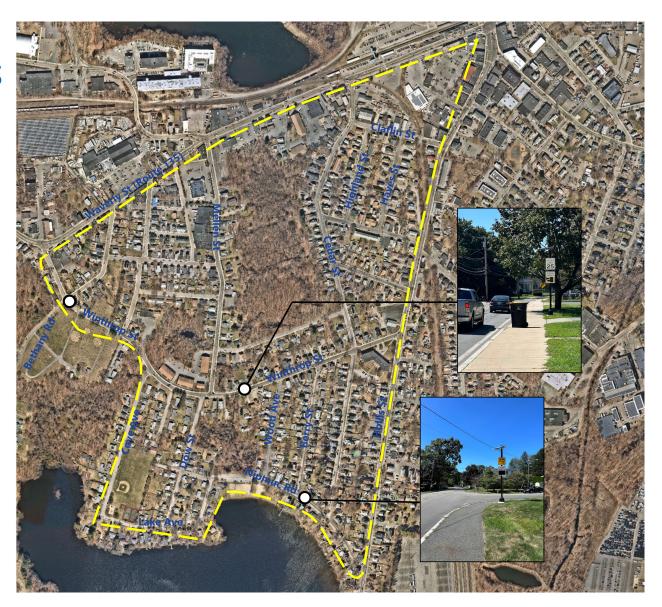
- 1. Cedar Street
- 2. Winthrop Street
- 3. Gilbert Street
- 4. Berry Street
- 5. Wood Avenue
- 6. Dow Street
- 7. Nipmuc Road
- 8. Lake Avenue
- 9. Cove Avenue
- 10. Bethany Road
- 11. Fay Road

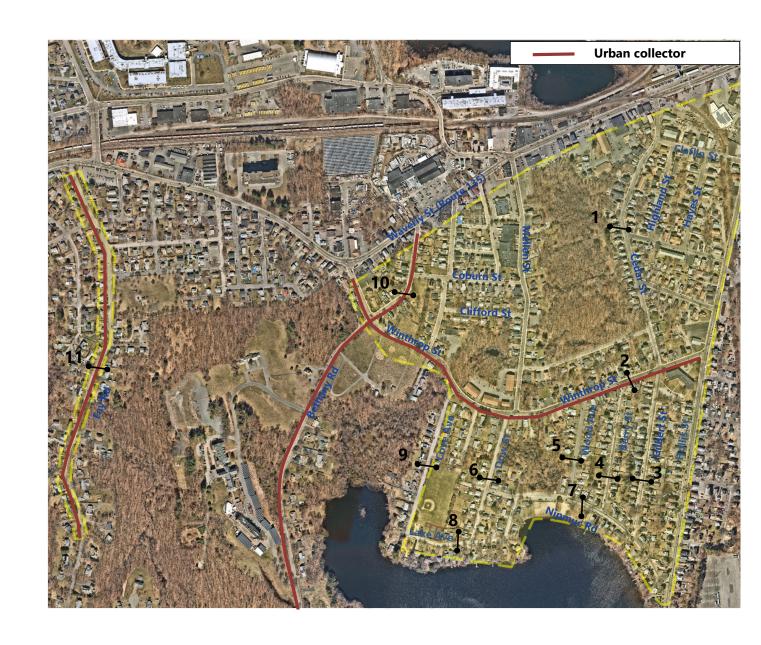
- Cove Ave, Lake Ave, Wood Ave, Berry St, Gilbert St
 - Low Volume Roads
- Dow St & Nipmuc Rd
 - Local roads
 - Volumes comparable to other urban collector roadways
 - Cut-through road between Rt 135 (Waverly St) and Rt 126 (Hollis St)

/		
Loca	tion	Daily	AM		PM	
1.	Cedar St	1,420	95	52% NB	125/	61% SB
2.	Winthrop St	5,550	450	59% SB	545	58% NB
3.	Gilbert St	490	30	57% NB	65	54% SB
4.	Berry St	200	20	68% NB	20	61% NB
5.	Wood Ave	410	50	82% NB	40	57% NB
6.	Dow St	2,545	175	58% NB	245	54% SB
7.	Nipmuc Rd	2,670	190	59% WB	255	52% EB
8.	Lake Ave	170	10	67% EB	20	63% EB
9.	Cove Ave	265	15	60% NB	35	62% SB
10.	Bethany Rd	1,205	85	70% NB	110	60% NB
11.	Fay Rd	2,145	170	61% NB	205	59% SB
